**COMPARATIVE PERFORMANCE OF STRUCTURAL LAYERS IN
PAVEMENT SYSTEMS**

**VOLUME I. DESIGN, CONSTRUCTION, AND BEHAVIOR
UNDER TRAFFIC OF PAVEMENT TEST SECTIONS**

ARMY ENGINEER WATERWAYS EXPERIMENT STATION

**PREPARED FOR
FEDERAL AVIATION ADMINISTRATION**

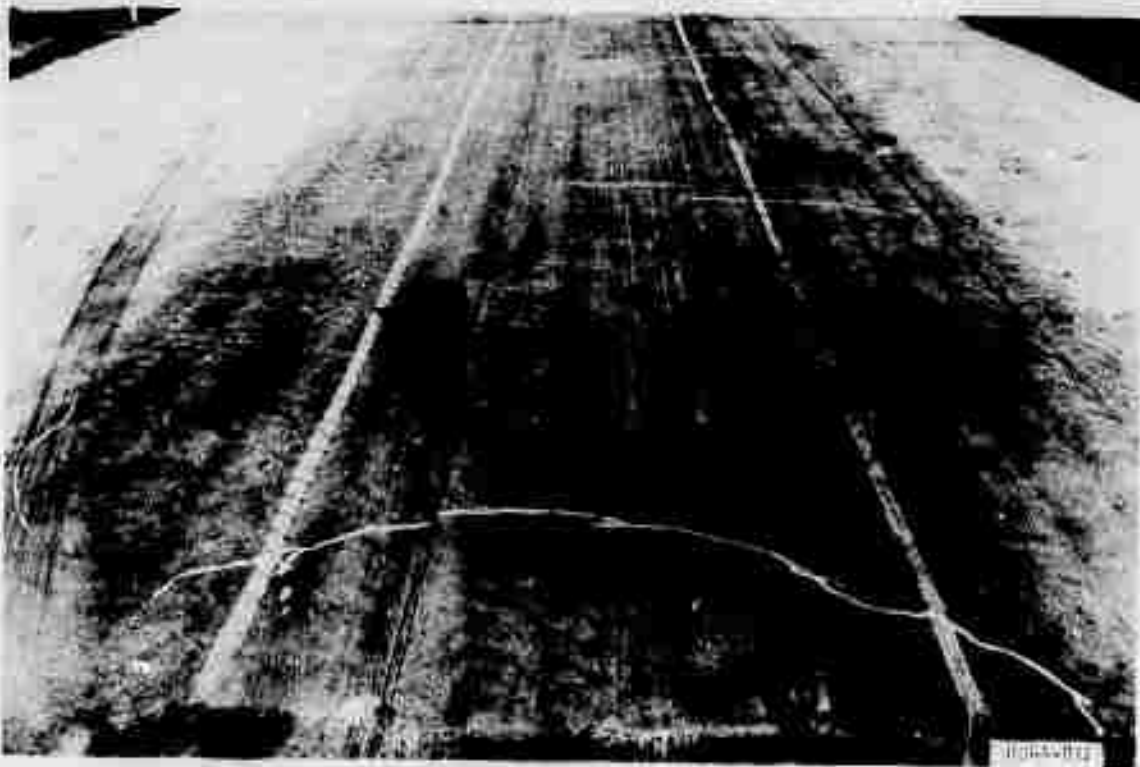
Figure A2. Item 1, lane 1, rigid pavement test section, after 200 coverages by 200-kip twin-tandem assembly

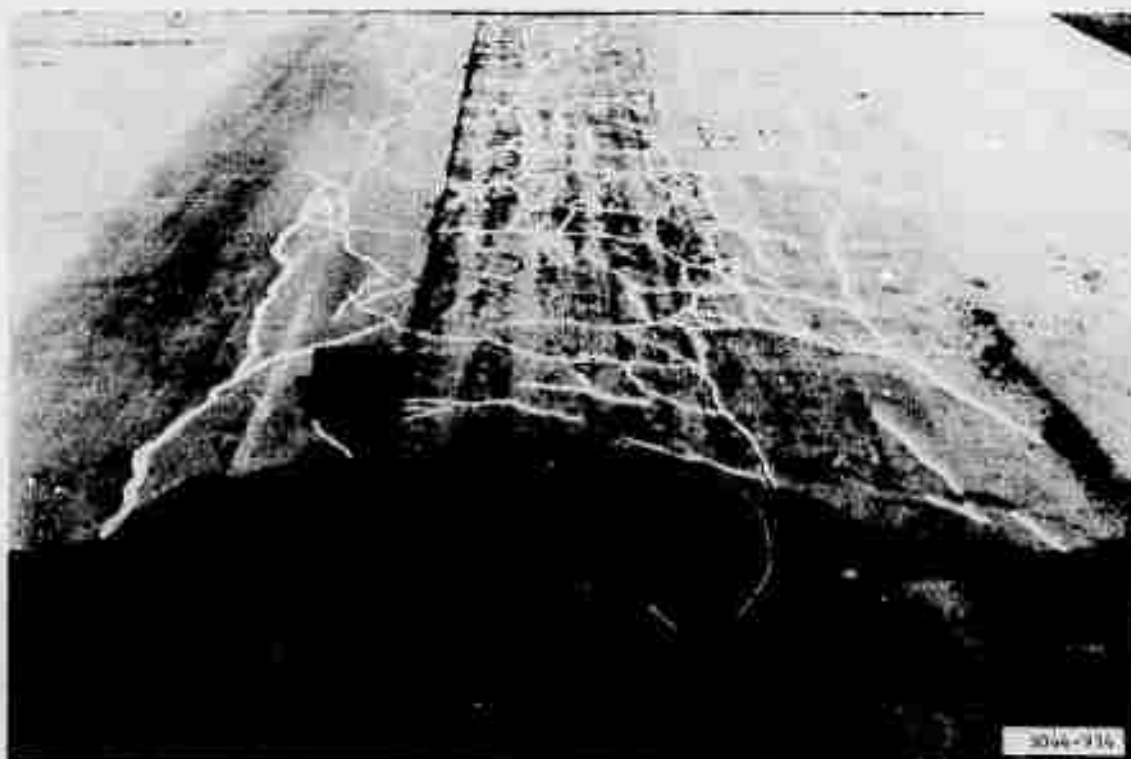
Item 1. The pavement structure in item 1 consisted of 7 in. of fibrous-reinforced concrete over a 20-in.-thick MESL base course. At 3000 coverages of the 200-kip load, the entire item was severely cracked and was considered to have reached the complete failure condition. Under the 240-kip load in lane 2, cracking became severe over the entire item at 1010 coverages, and the item was considered to have reached the complete failure condition.

Figure A4. Item 1, lane 1, rigid pavement test section, after
3000 coverages by 200-kip twin-tandem assembly

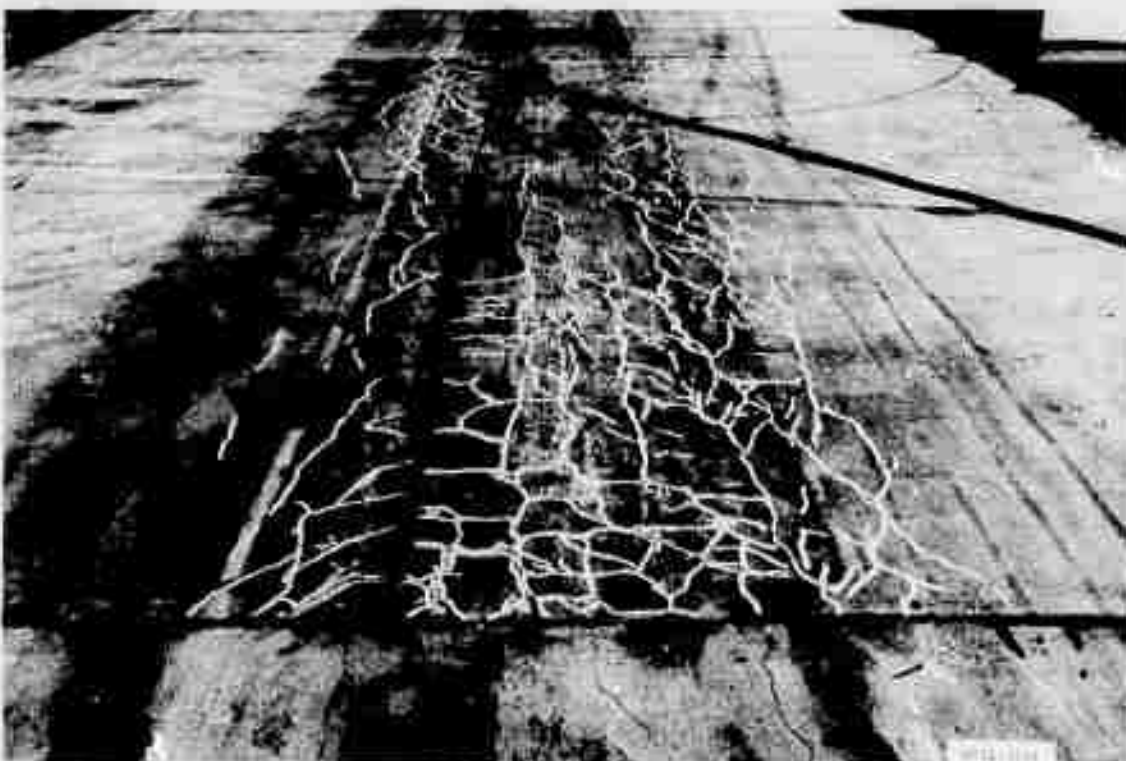
1770 coverages of the 200-kip load and at 740 coverages of the 240-kip load. Both failures were due to severe cracking of the fibrous-reinforced concrete.

Figure A10. Item 2, lane 1, rigid pavement test section, after 1770 coverages by 200-kip twin-tandem assembly

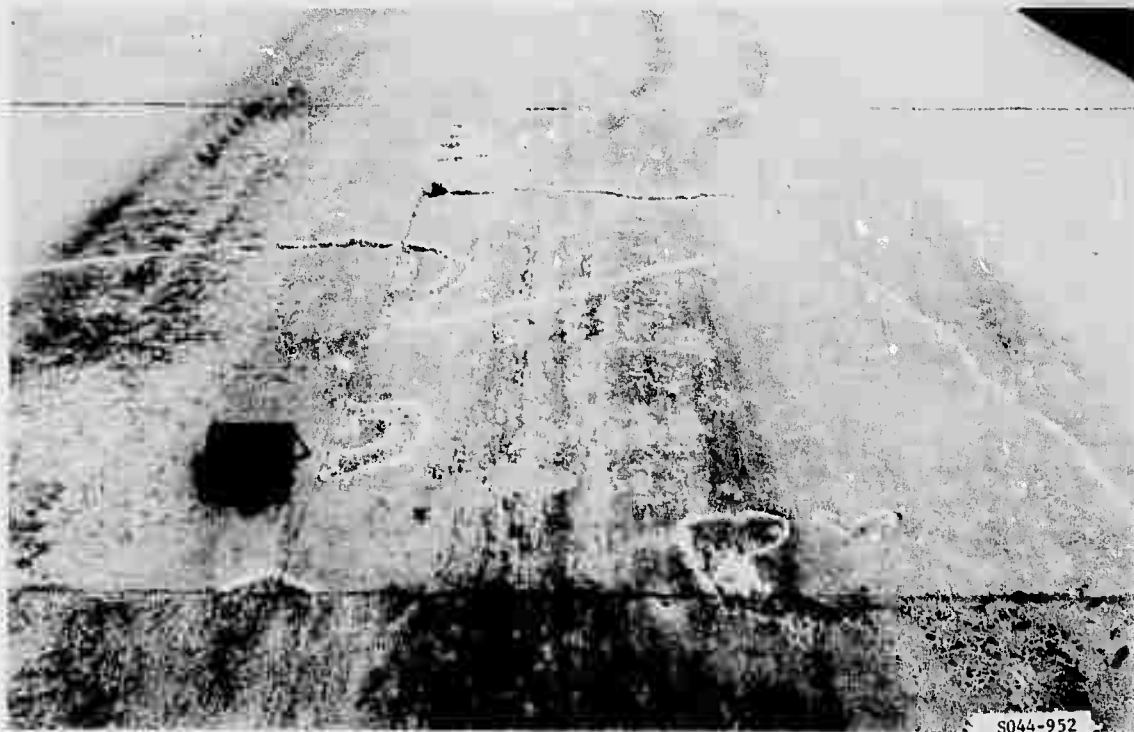
Figure A15. Item 3, lane 1, rigid pavement test section, after 6360 coverages by 200-kip twin-tandem assembly

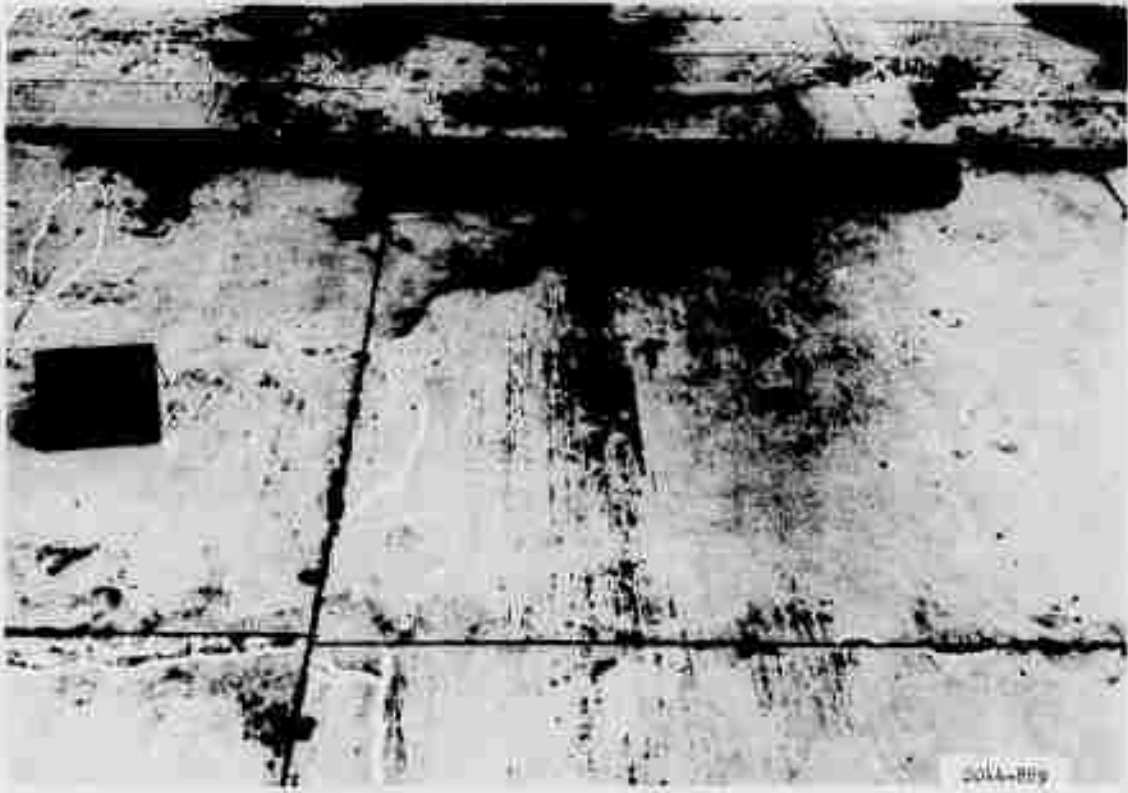
Figure A25. Subitem 5b, lane 1, rigid pavement test section,
after 1770 coverages by 200-kip twin-tandem assembly

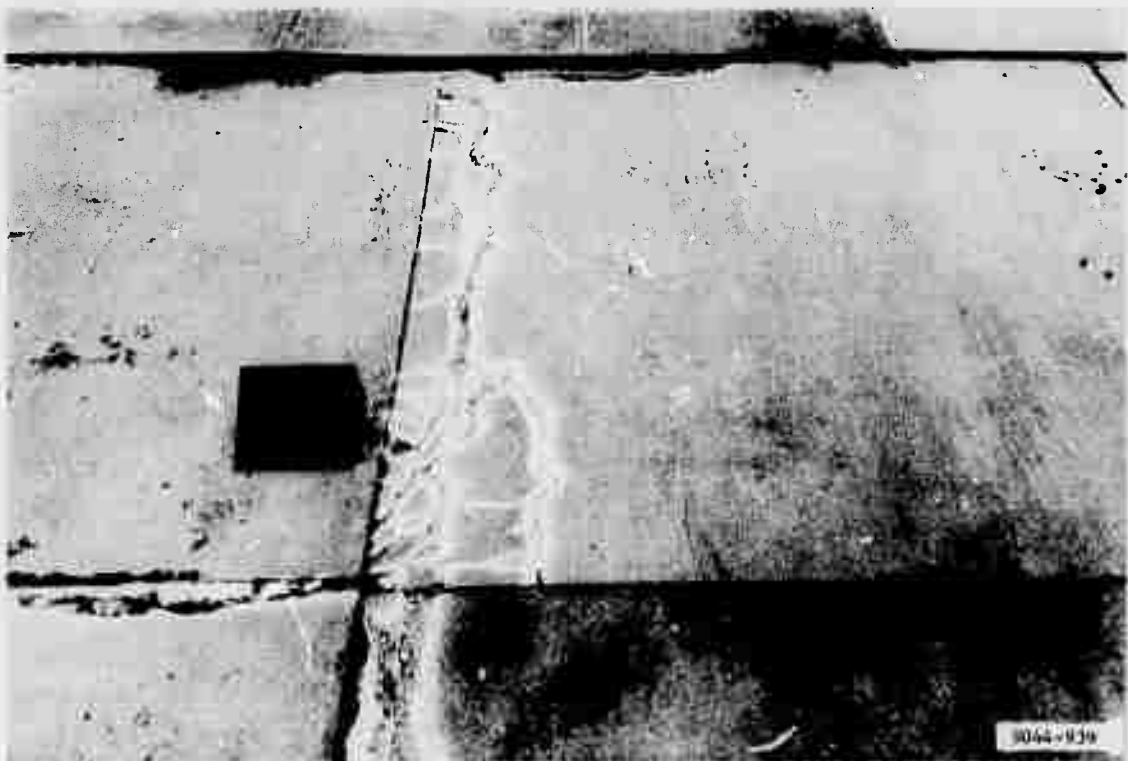
Figure A26. Subitem 5b, lane 1, rigid pavement test section,
after 3000 coverages by 200-kip twin-tandem assembly

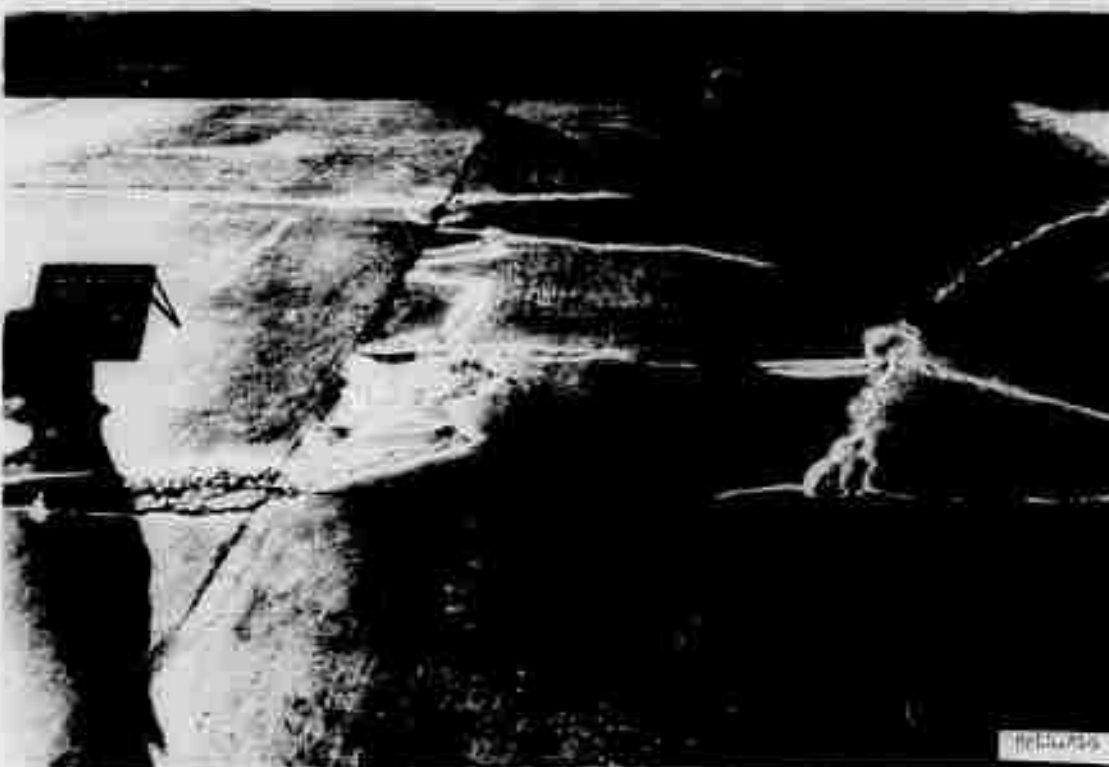
Figure A28. Subitem 5c, lane 1, rigid pavement test section, after 1230 coverages by 200-kip twin-tandem assembly

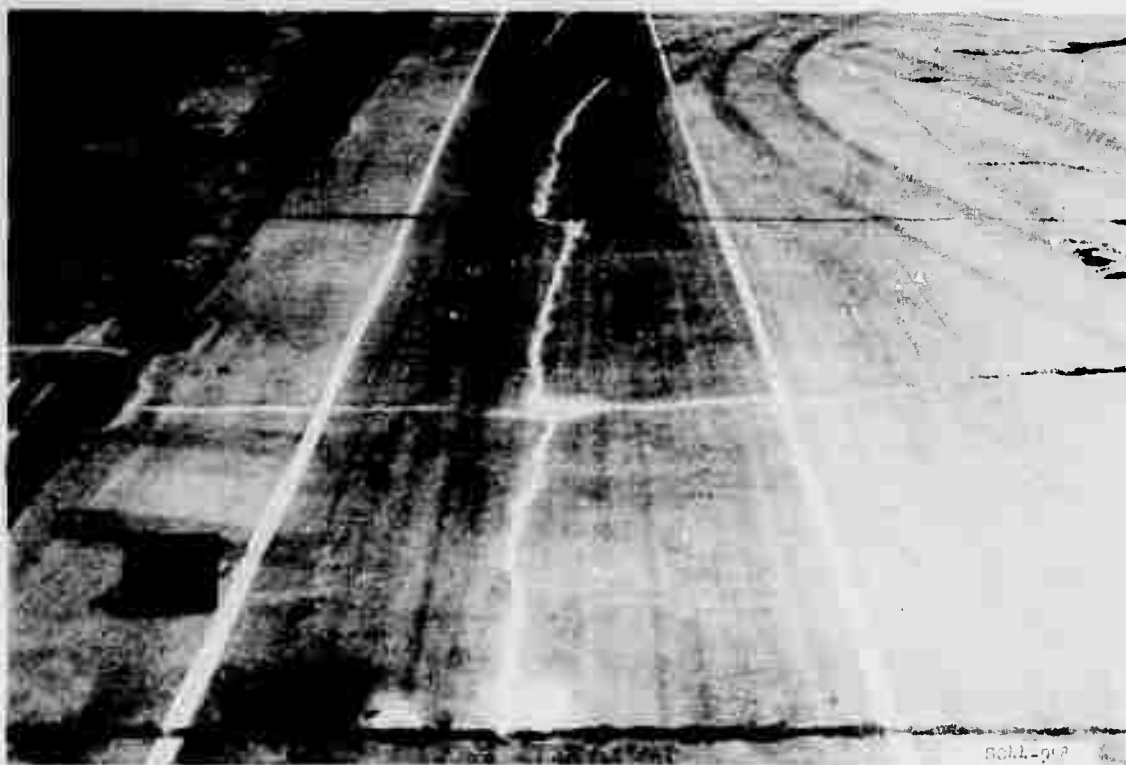
Figure A41. Item 3, lane 2, rigid pavement test section, after 200 coverages by 240-kip twin-tandem assembly

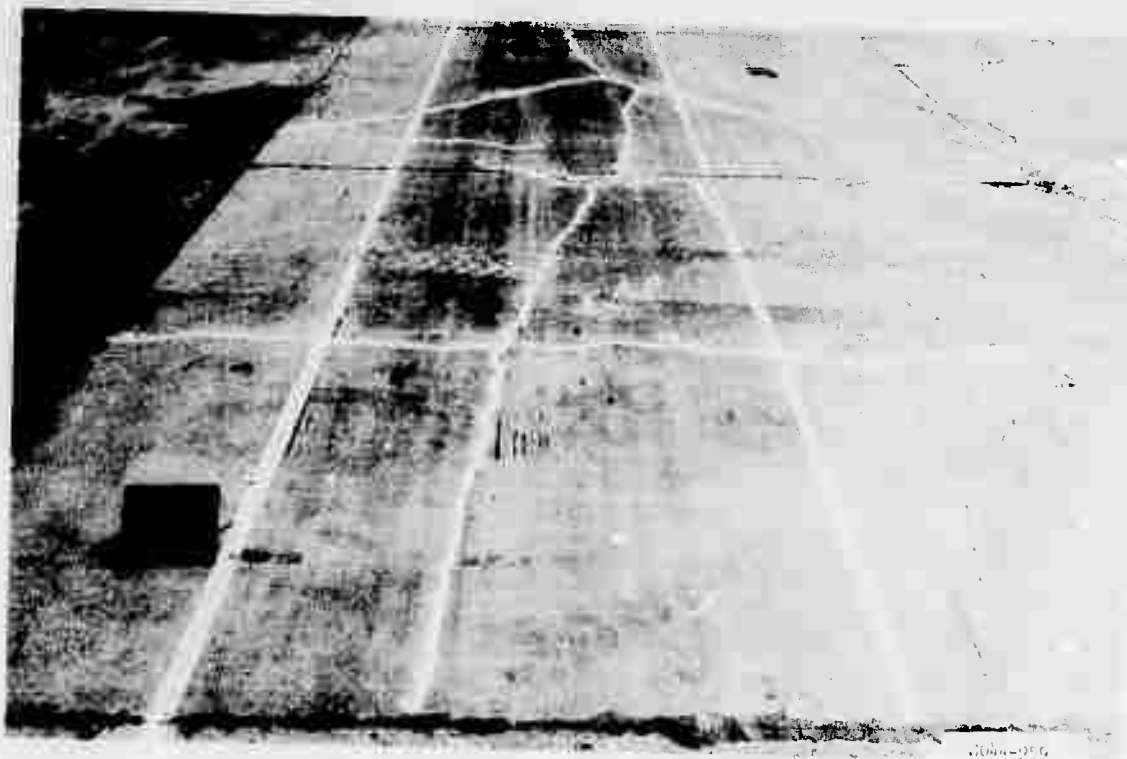
Figure A45. Item 4, lane 2, rigid pavement test section, after 200 coverages by 240-kip twin-tandem assembly

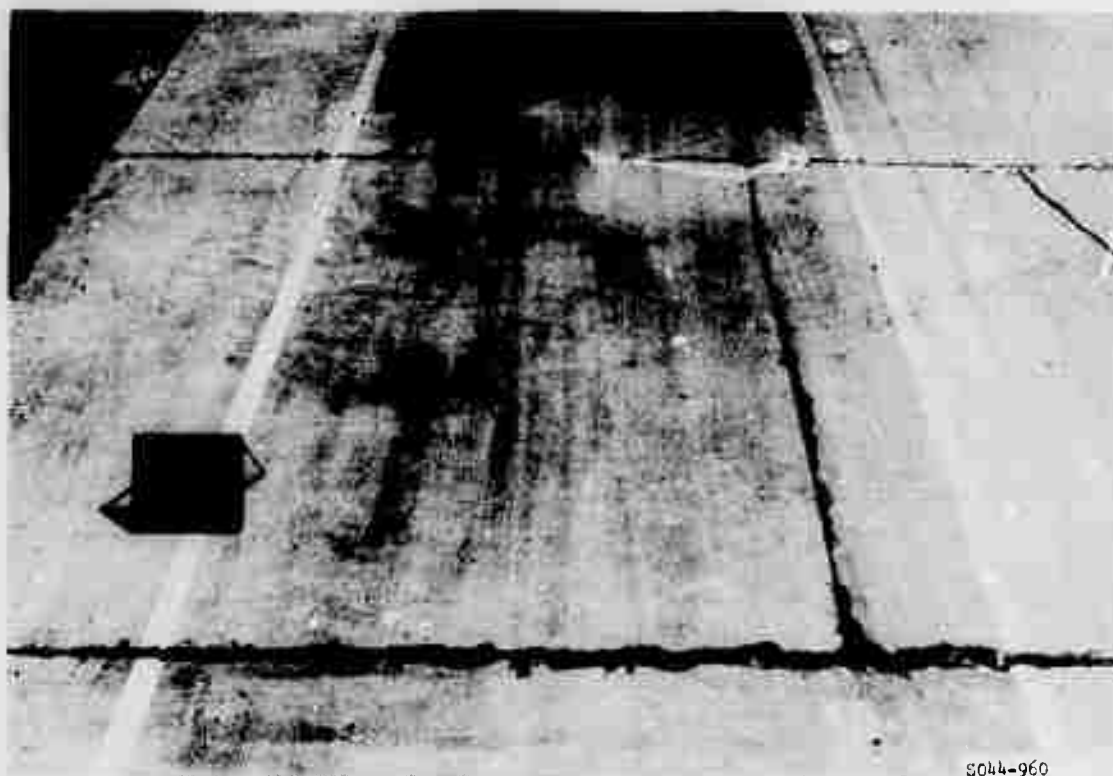
Figure A48. Subitem 5a, lane 2, rigid pavement test section, after 200 coverages by 240-kip twin-tandem assembly

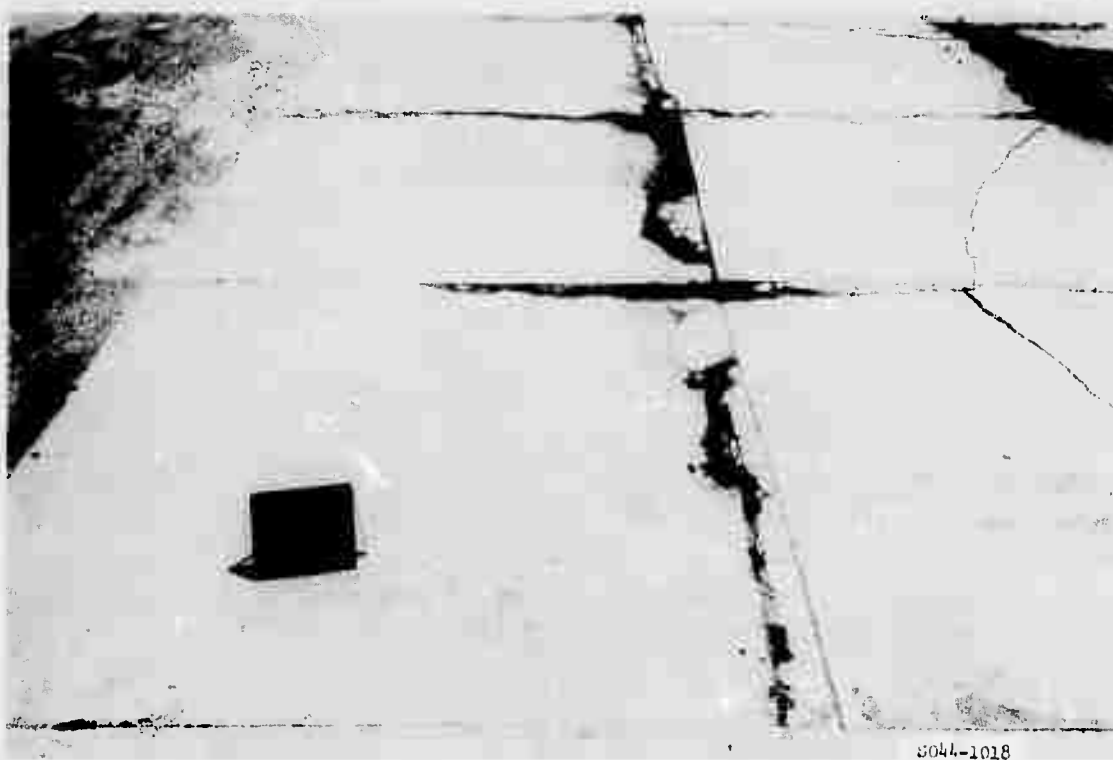
Figure A49. Subitem 5a, lane 2, rigid pavement test section, after 950 coverages by 240-kip twin-tandem assembly

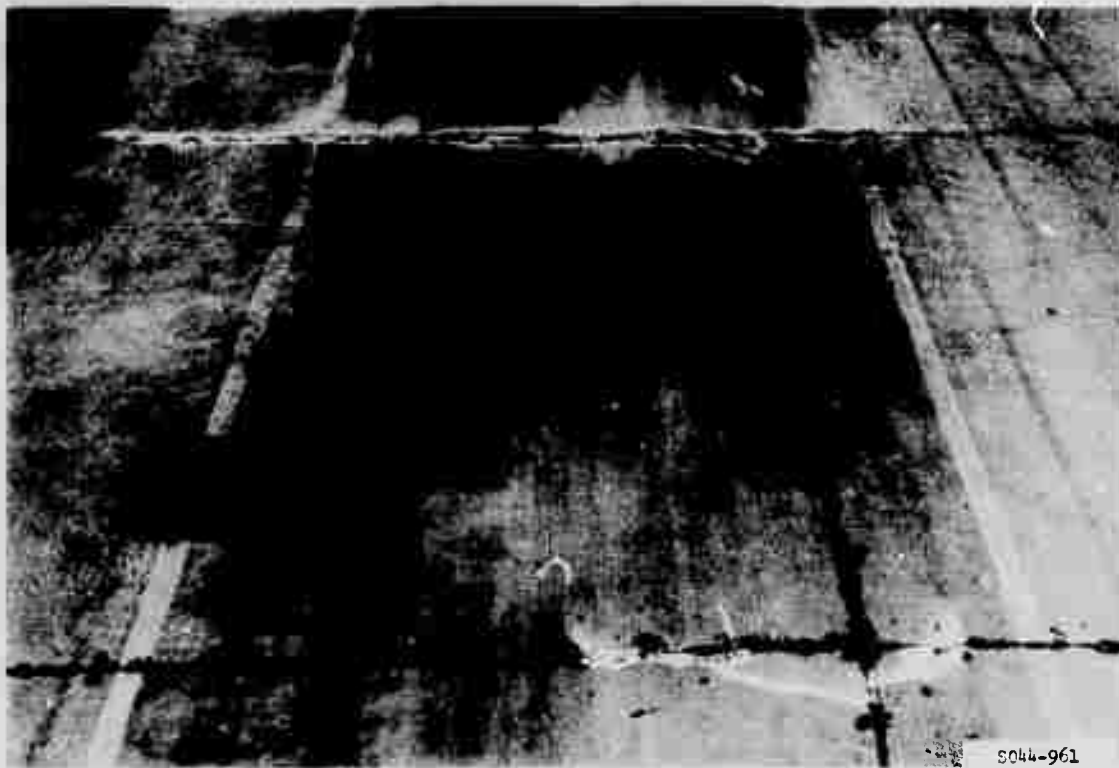
Figure A51. Subitem 5b, lane 2, rigid pavement test section, after 200 coverages by 240-kip twin-tandem assembly

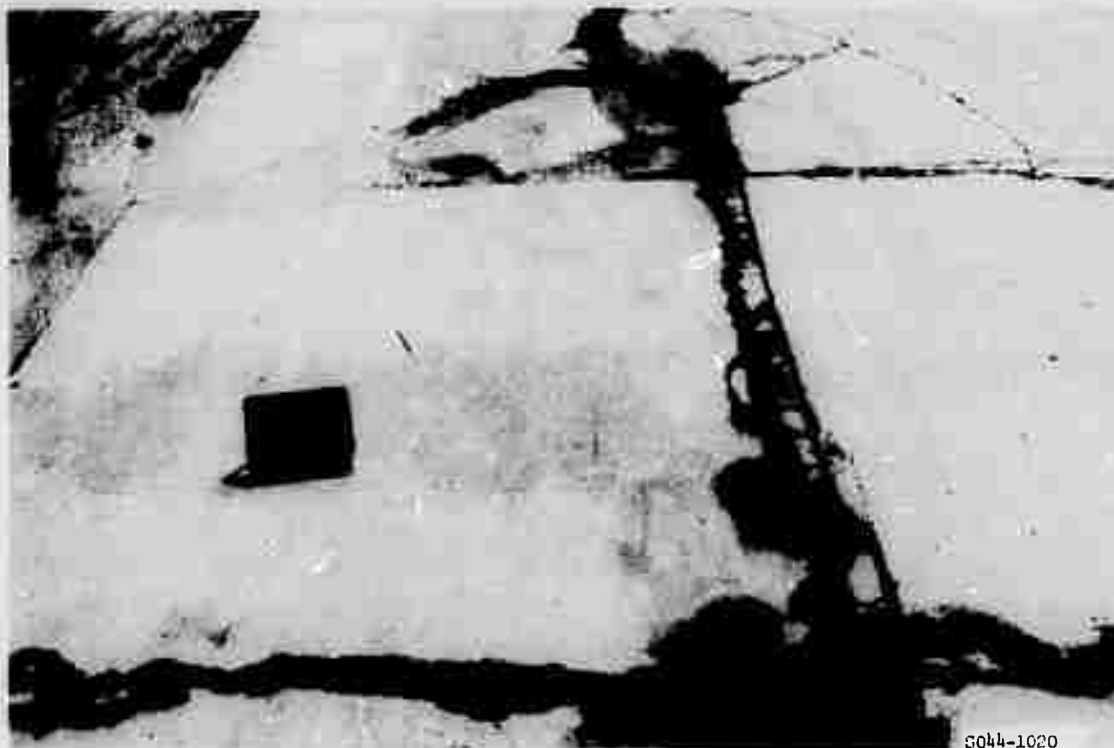
Figure A54. Subitem 5c, lane 2, rigid pavement test section, after 840 coverages by 240-kip twin-tandem assembly

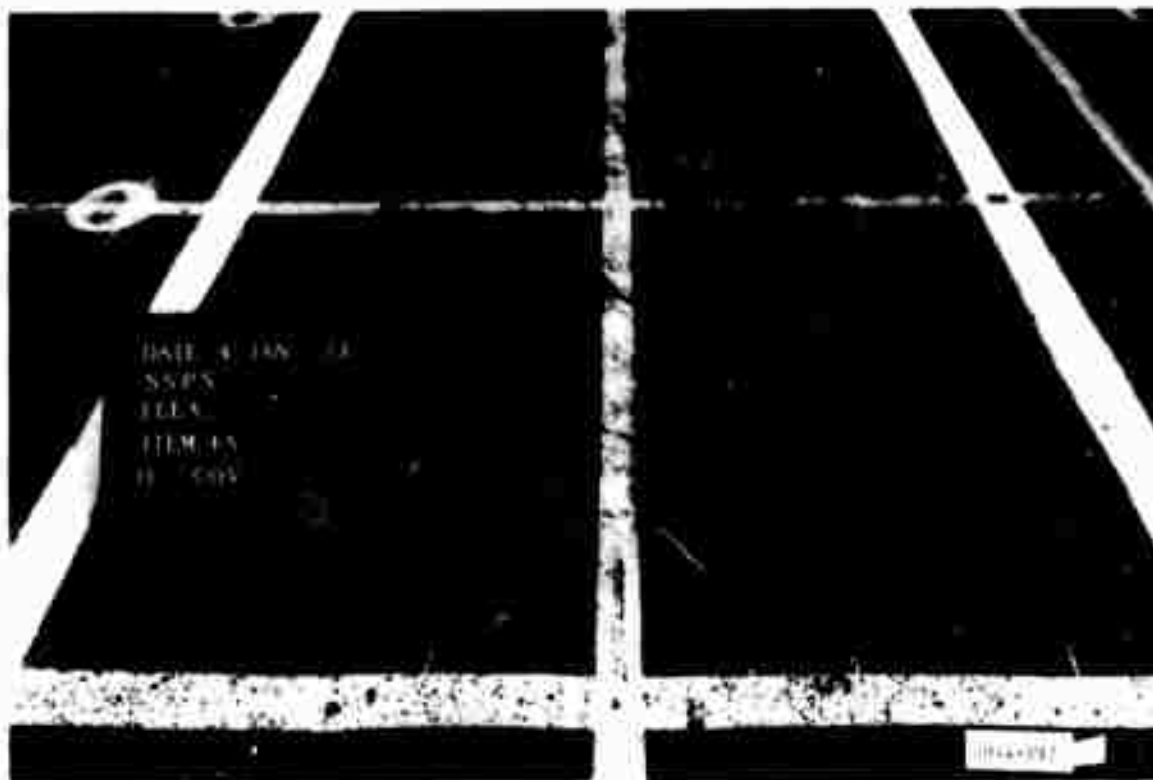
Figure B51. Subitem 4a, lane 3, flexible pavement test section, prior to traffic

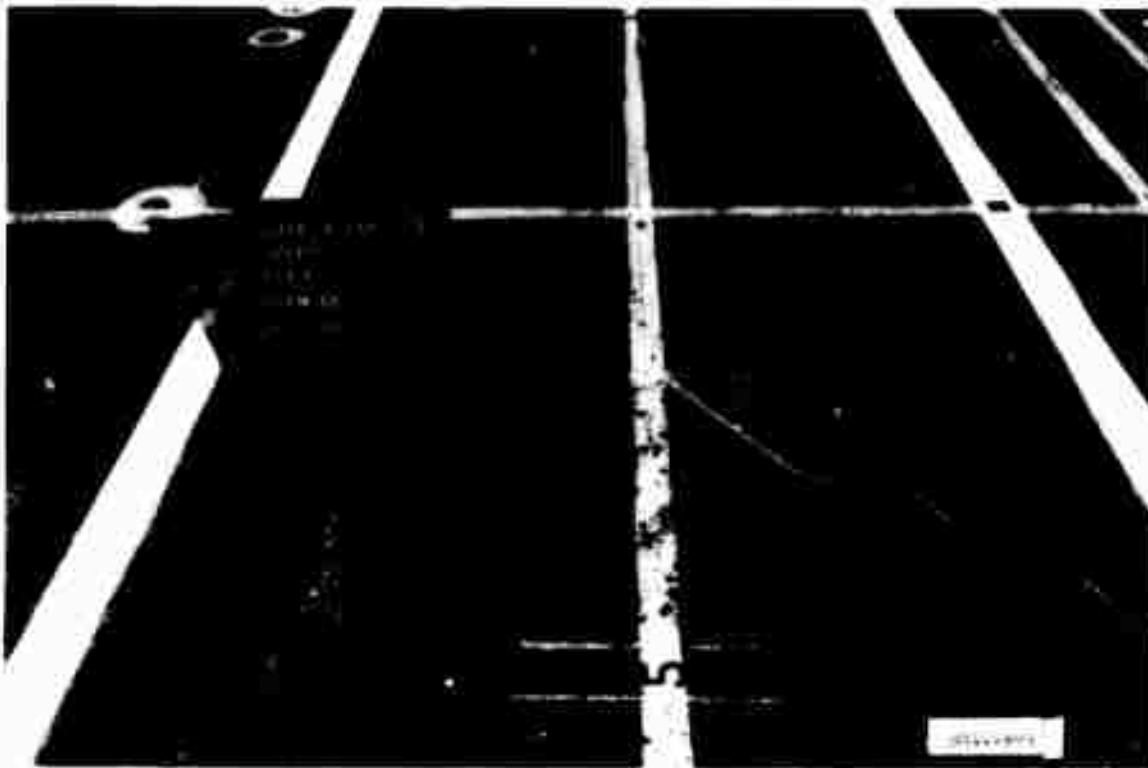
Figure B53. Subitem 4b, lane 3, flexible pavement test section, prior to traffic

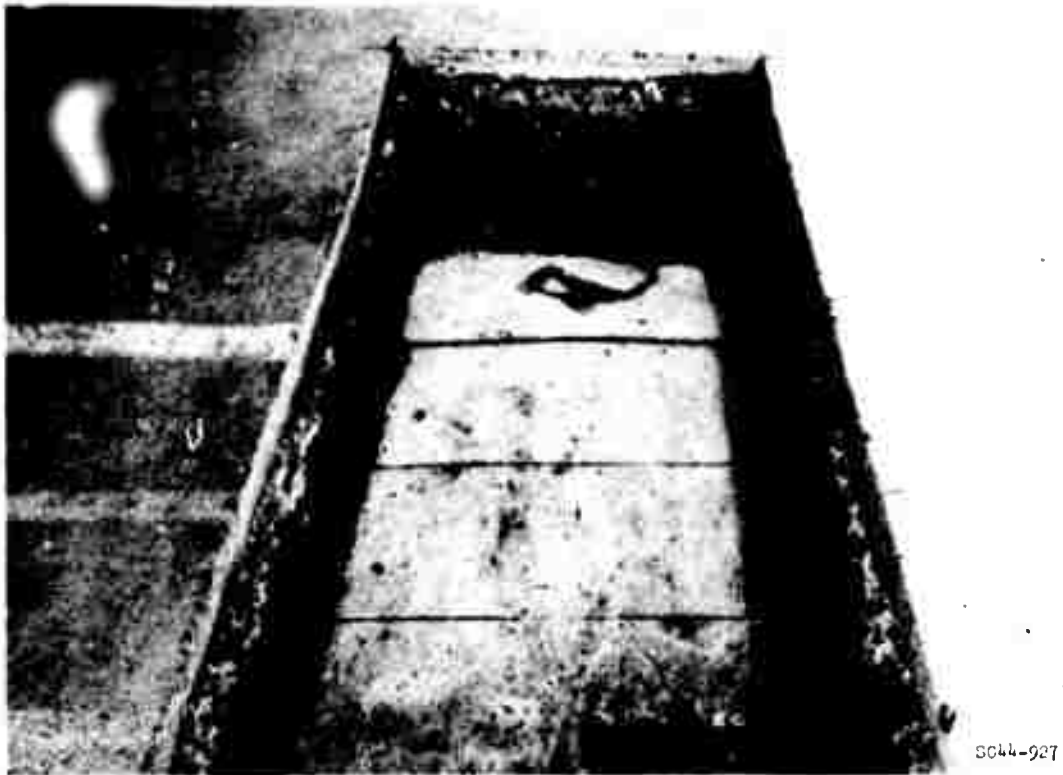
Subitem 5c. The results of in-place tests performed in the test trench in subitem 5c showed no significant difference for values obtained inside and outside the traffic lane. Data obtained in the test trench are shown in Table 14 of the main text. The polystyrene in subitem 5c was placed with the long dimension of the panels parallel to the direction of traffic. No cracks were noted in the polystyrene panels, although about 1 in. of permanent deformation occurred at the surface of the pavement in the traffic lane. A view of the surface of the panels is shown in Figure B81.

Figure B81. Surface of polystyrene panels in subitem 5c, lane 3, flexible pavement test section, after traffic
